City of Jersey Village Clark Henry Pool Study June 12, 2024

The City of Jersey Village, Texas commissioned Counsilman-Hunsaker to conduct a conditions assessment of the existing outdoor swimming pool that consists of a main pool with 6, 25-yard lanes, along with a shallow area and a deep-water area that contains a diving board, climbing wall and drop slide, as well as a 200 square foot children’s pool. The outdoor pool opened in 1975 and is currently utilized for a variety of aquatic activities and programs during the summer including, recreation swim, summer swim team, water fitness classes and swimming lessons.

Conditions Assessment Summary

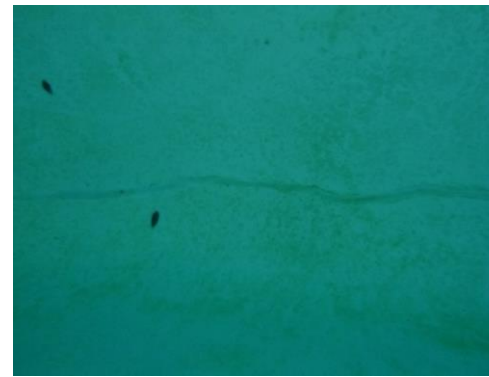
- The swimming pool has a concrete structure with a plaster finish. There were areas of etching and delaminating plaster at several areas in the pool. A large crack is visible throughout the surface of the pool spanning from the shallow end by the starting blocks to the deep end. Staff report the crack has been in the pool since at least 2021. The crack is close to an inch wide and has been filled by maintenance staff to prevent water loss. The corners of the pool were in poor condition with missing plaster, cracking, missing tile and exposed concrete. While not uncommon for a pool of this age, it does indicate signs of structural movement and cracking in the pool shell. When structural cracking in a pool occurs, it can be created by many factors. Structural failure will continue until the issue is addressed. Furthermore, structural cracking allows water (pool or hydrostatic ground water) to penetrate the concrete and reach the embedded rebar. The result is corroded and eventual failed rebar which can further weaken the pool structure.

Figure 1.1, Crack in pool structure

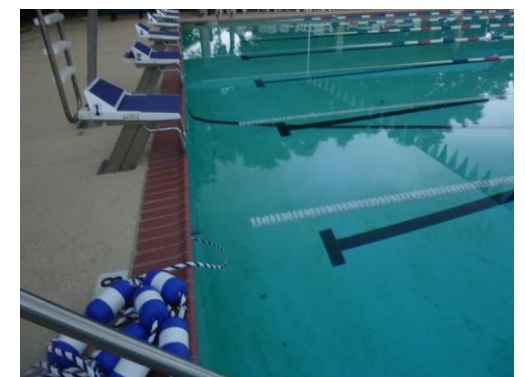
Figure 1.2, Area of large crack

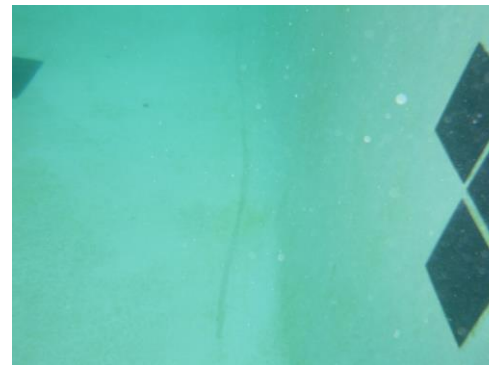
Figure 1.3, Crack in pool structure

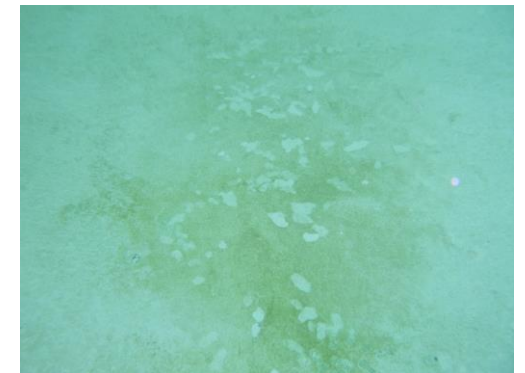
Figure 1.4, Plaster surface etching/delamination

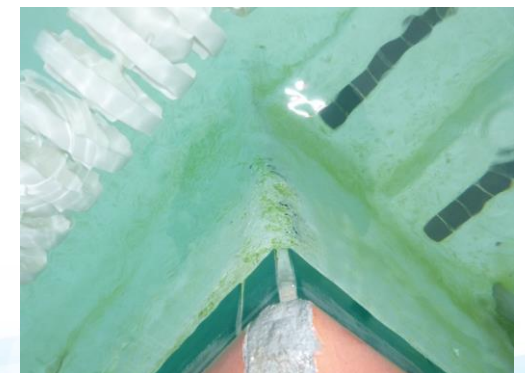
Figure 1.6, Cracking, delamination on corner

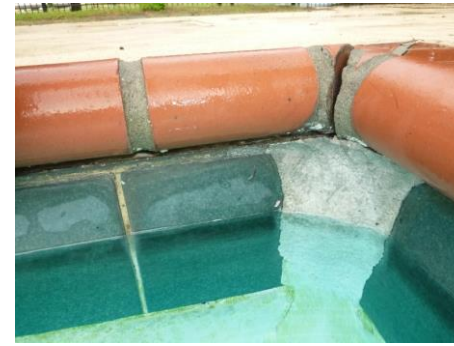
- Cracking was also observed in the pool's perimeter precast coping stone and gaps exist between the perimeter pool tile and coping stone. Staff have repaired and patched these areas with concrete though some of the patches need repairing. In two separate areas the coping stone was able to be pulled up as it was not attached to the top of the concrete wall. Areas specific to the corners of the pool also had issues with the condition of the coping stone and large gaps and cracking. When gaps exist in the pool's coping stone it allows water to penetrate behind and in between the stone. When water gets behind the coping stone it can create movement in the stone. These areas should be secured, patched and filled before the start of the 2024 pool season.

Figure 1.7, Coping stone loose and cracking

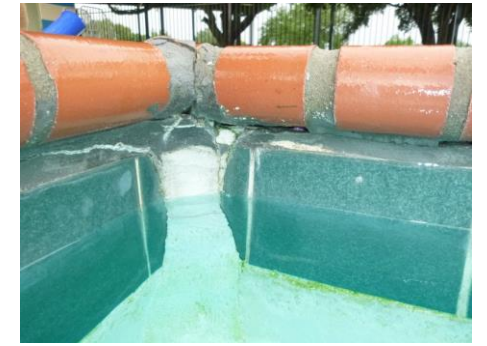
Figure 1.8, Area of corner wall repair

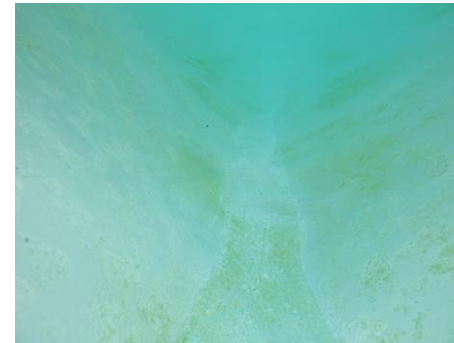
Figure 1.9, Area of corner wall repair

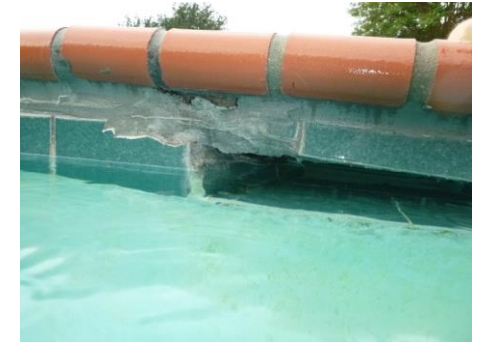
Figure 1.10, Cracked, shifting skimmer basket

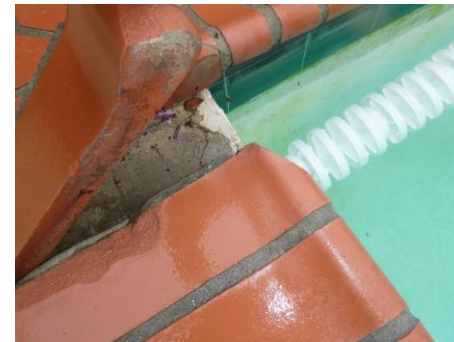
Figure 1.11, Loose/unsecured coping stone

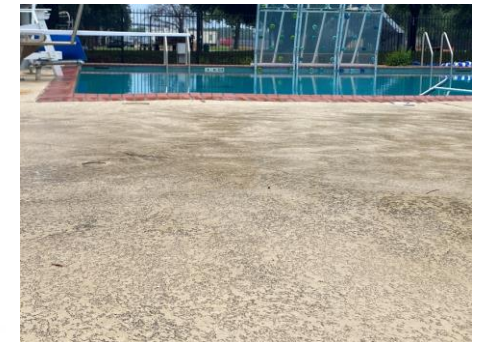
Figure 1.12, Uneven/shifting concrete deck and pool

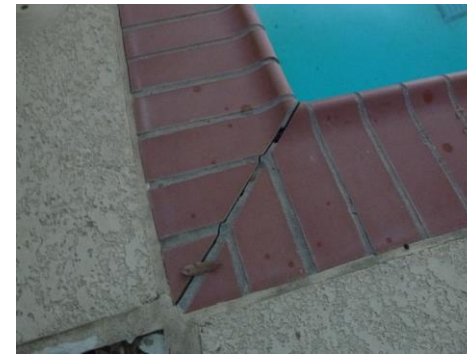
Figure 1.13, Coping stone cracking

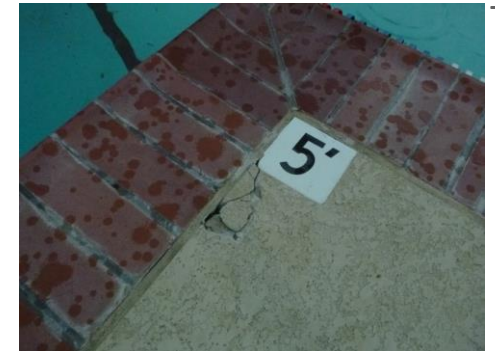
- The concrete pool deck shows signs of cracking around the perimeter of the pool and has areas that are uneven or where concrete is missing in several locations. The top coating is also delaminating in numerous locations. The main issues with the pool deck are the areas of missing concrete that can cause safety hazards for guests walking around without their shoes. Staff have patched areas that have cracked and delaminated to ensure the safety of pool users, but a few areas still need to be addressed. There is also significant shifting the pool deck as evidenced by the fact that the pool deck was replaced 3 years ago and there is already cracking, heaving and swelling of the deck. A key location this has occurred is on the north side of the deep end where the deck and coping stone are wavy.

Figure 1.14, Pool deck delamination

Staff should continue to monitor the condition of the pool deck and repair areas as needed. A complete replacement of the pool deck is not recommended at this time though repairs should be made to areas of concern.

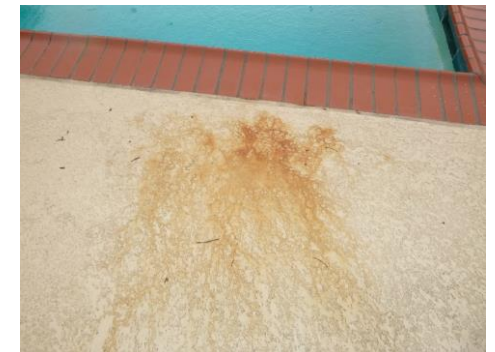
Figure 1.18, Pool deck corrosion

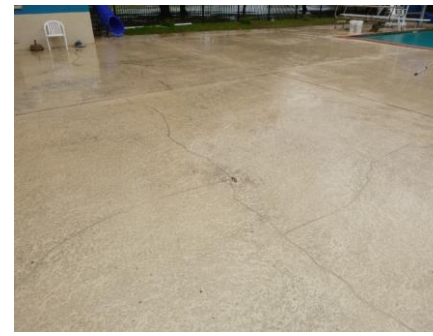
Figure 1.19, Pool deck cracking

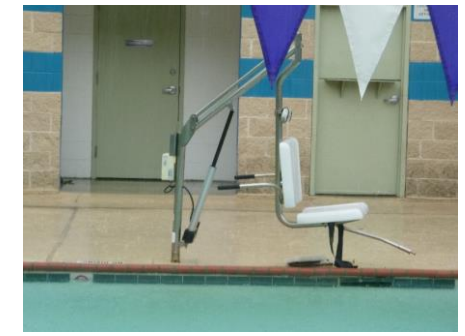
- The pool contains a lift but it was not functional during the site visit. The ladders and stair entry do not qualify for a compliant entry. To meet the ADA standards the pool should have two compliant lifts installed, or a single lift and convert the smaller stair entry on the east side of the pool to a compliant stair entry with handrails.

Figure 1.20, ADA pool lift

- Another option would be to install a new ADA lift along with an ADA compliant portable stair entry system similar to <https://www.recreonics.com/product/aqua-step-4-step/>.

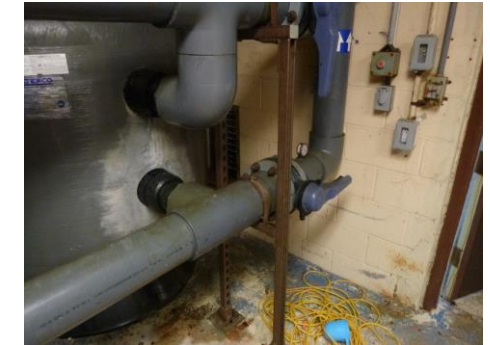
Figure 1.28, Piping support corrosion | area of filter leak

- The visible, above ground recirculation piping for the pool's gutter system and main drain in the pool mechanical room are Schedule 80 PVC that was installed during the 2008 renovation. Several of the pipe supports show signs of corrosion. Overall, the piping for the pool is in good condition. The 6" recirculation piping is adequate for the 300 GPM flow rate, but it is not rated for a 700 GPM flow rate which is necessary to meet the code requirement of a 6-hour turnover. In order to achieve the required turnover rate a complete renovation of the recirculation system is required including all new piping in the mechanical room and to the swimming pool. This would require a complete demolition and reinstallation of the existing pool deck to reach all of the subgrade piping.

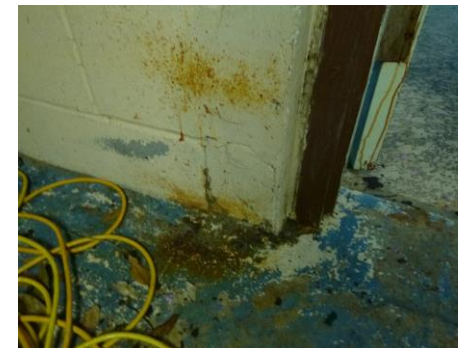
Figure 1.29, Wall/door deterioration

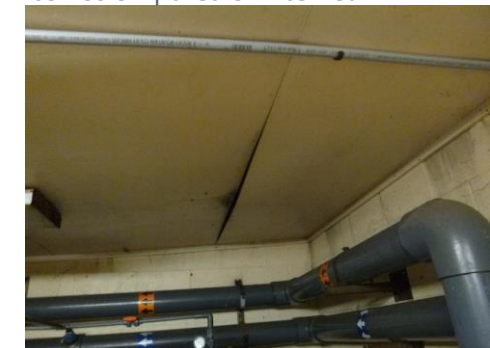
Figure 1.30, Mechanical room ceiling damage

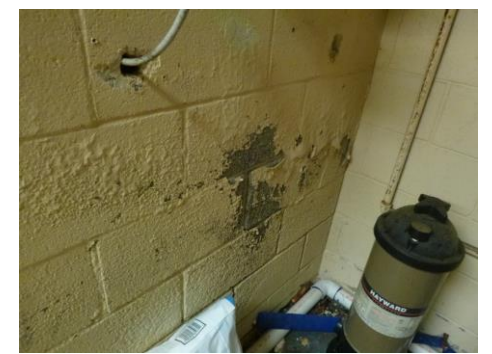
Figure 1.32, Mechanical room wall deterioration

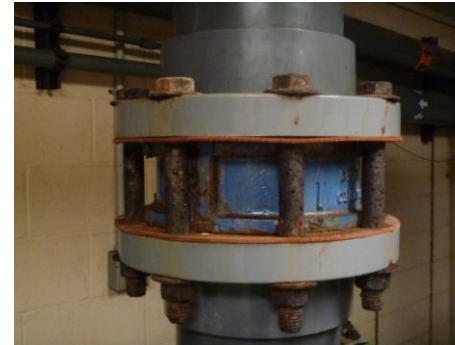
Figure 1.33, Piping bolt corrosion

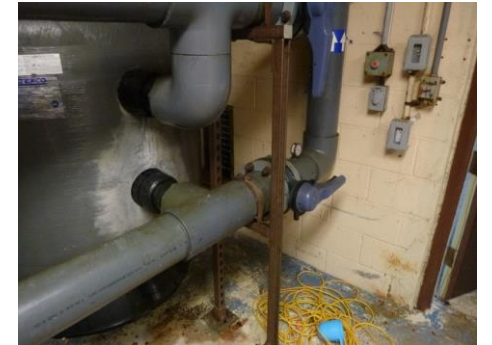
Figure 1.34, Piping support corrosion | area of filter leak

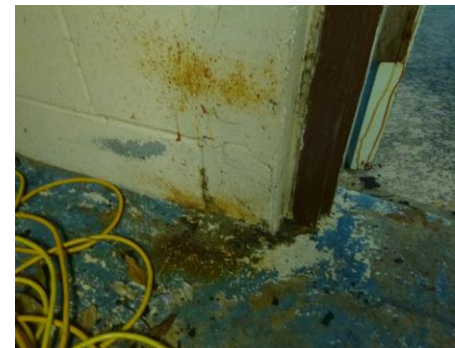
Figure 1.35, Wall/door deterioration

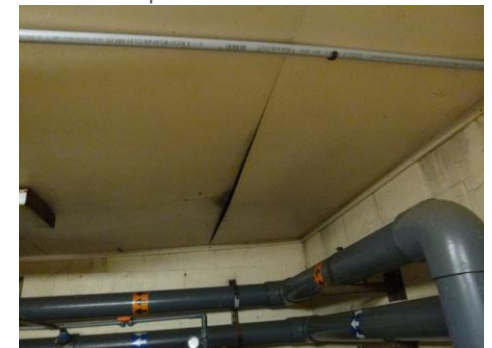
Figure 1.36, Mechanical room ceiling damage

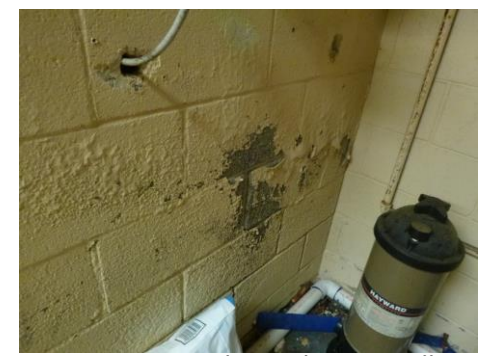
Figure 1.38, Mechanical room wall deterioration

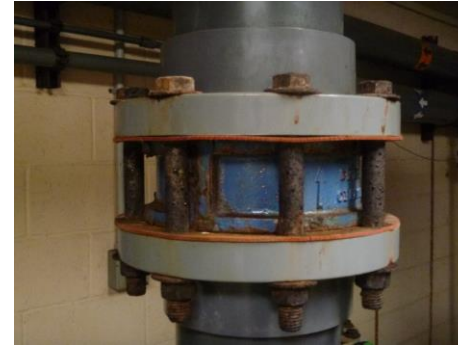
Figure 1.39, Piping bolt corrosion

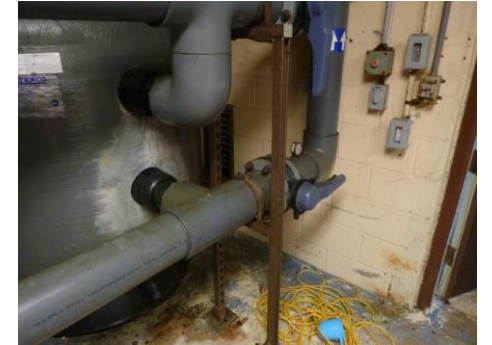
Figure 1.40, Piping support corrosion | area of filter leak

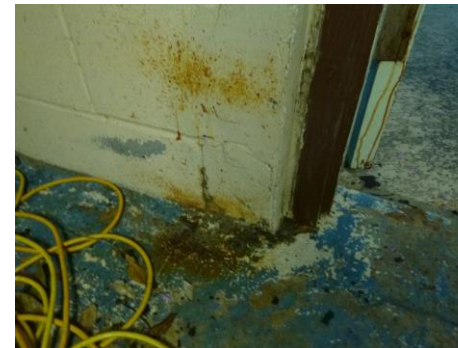
Figure 1.41, Wall/door deterioration

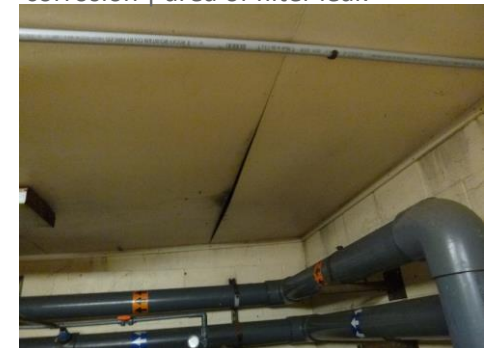
Figure 1.42 Mechanical room ceiling damage

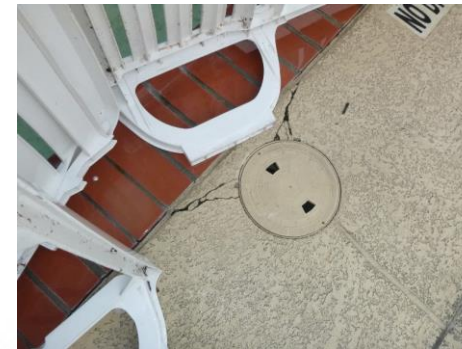
Deck/skimmer cracking
