City of Jersey Village Clark Henry Pool Study June 12, 2024

The City of Jersey Village, Texas commissioned Counsilman-Hunsaker to conduct a conditions assessment of the existing outdoor swimming pool that consists of a main pool with 6, 25-yard lanes, along with a shallow area and a deep-water area that contains a diving board, climbing wall and drop slide, as well as a 200 square foot children’s pool. The outdoor pool opened in 1975 and is currently utilized for a variety of aquatic activities and programs during the summer including, recreation swim, summer swim team, water fitness classes and swimming lessons.

Conditions Assessment Summary

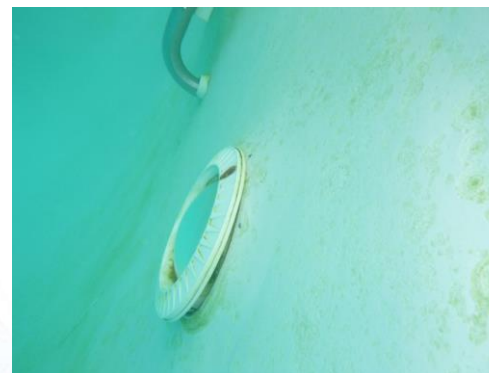
Figure 1.5, Underwater light not in place

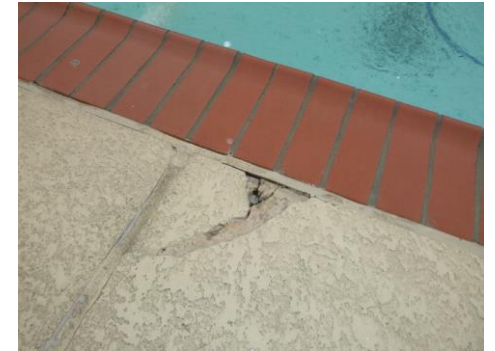
- The concrete pool deck shows signs of cracking around the perimeter of the pool and has areas that are uneven or where concrete is missing in several locations. The top coating is also delaminating in numerous locations. The main issues with the pool deck are the areas of missing concrete that can cause safety hazards for guests walking around without their shoes. Staff have patched areas that have cracked and delaminated to ensure the safety of pool users, but a few areas still need to be addressed. There is also significant shifting the pool deck as evidenced by the fact that the pool deck was replaced 3 years ago and there is already cracking, heaving and swelling of the deck. A key location this has occurred is on the north side of the deep end where the deck and coping stone are wavy.

Figure 1.16, Pool deck delamination

Staff should continue to monitor the condition of the pool deck and repair areas as needed. A complete replacement of the pool deck is not recommended at this time though repairs should be made to areas of concern.

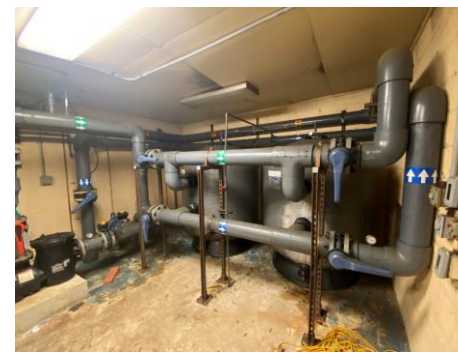
Figure 1.37, Pool mechanical system

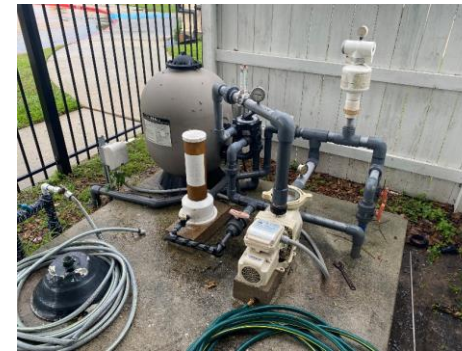
Children's pool mechanical system
