City of Jersey Village Clark Henry Pool Study June 12, 2024

The City of Jersey Village, Texas commissioned Counsilman-Hunsaker to conduct a conditions assessment of the existing outdoor swimming pool that consists of a main pool with 6, 25-yard lanes, along with a shallow area and a deep-water area that contains a diving board, climbing wall and drop slide, as well as a 200 square foot children’s pool. The outdoor pool opened in 1975 and is currently utilized for a variety of aquatic activities and programs during the summer including, recreation swim, summer swim team, water fitness classes and swimming lessons.

Conditions Assessment Summary

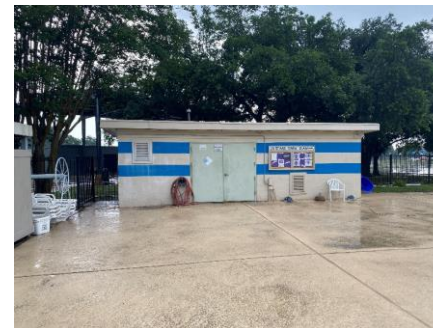
Figure 1.23, Pool mechanical building

- Pool mechanical building is in poor condition with lack of ventilation and isolation for pool chemicals
- Pool filtration is nearing the end of its expected lifespan and has had leaks in recent years

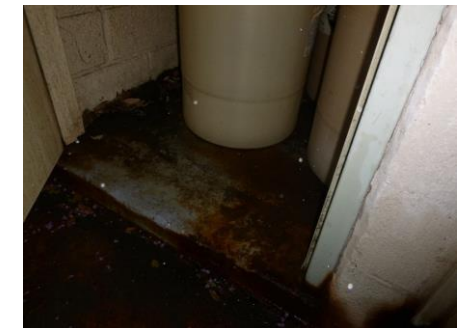
Figure 1.24, Chemical storage room

- The pool has an Accutab chlorinator that utilizes calcium hypochlorite (tablet chlorine) for the pool's sanitizer. Muriatic acid is used for the pH buffer and is stored in an adjacent room. The feed line for the acid comes through the wall into the main mechanical room which allow fumes to get into this space which has caused some level of corrosion on most of the equipment. There is minimal ventilation in this area and corrosion was observed on pipe supports, piping bolt connections, and electrical components. A separate dedicated and ventilated chemical storage room for both the sanitizer and pH buffer is recommended and is the current industry standard. These spaces are strongly recommended to be exhausted independently to the exterior, typically at rates around 15-20 air changes per hour, depending on specific code requirements. A plan for dedicated spaces for chemical storage in a future renovation should be developed.

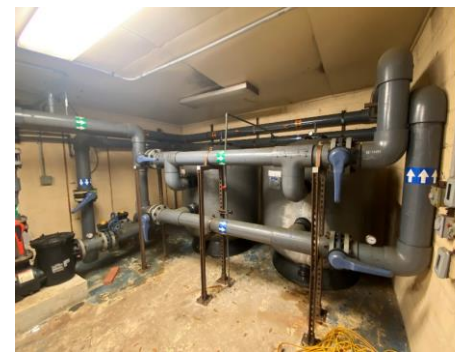
Figure 1.31, Pool mechanical system

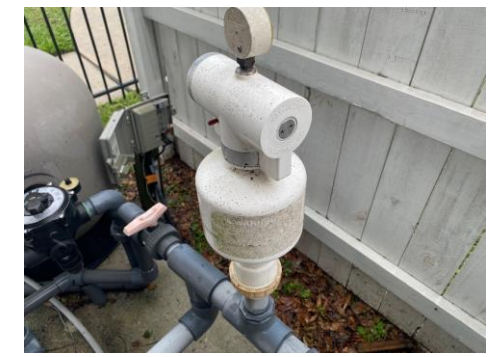
Children's pool SVRS

- Non-ADA compliant entry
 - Necessitates the construction of a ramp entry (1:12 slope) with ADA compliant handrails down to the depth of 1'6"
- Single main drain requires Safety Vacuum Release System (SVRS)
 - SVRS installed on the mechanical system but is not currently operating
- Children's pools are considered a Public Interactive Water Feature (PIWF) in the State of Texas
 - Necessitates secondary sanitation system (Ultraviolet Treatment System) to kill harmful bacteria associated with Recreational Water Illnesses
- Lack of chemical automation installed on the mechanical system to control chlorine and muriatic acid feeding.
- Cracking in the perimeter deck and coping stone was observed
- Lack of modern-day interactive aquatic amenities for children
